812911 Assembly, EZ Cam **NOTES:**

Assembly, EZ Cam 812911

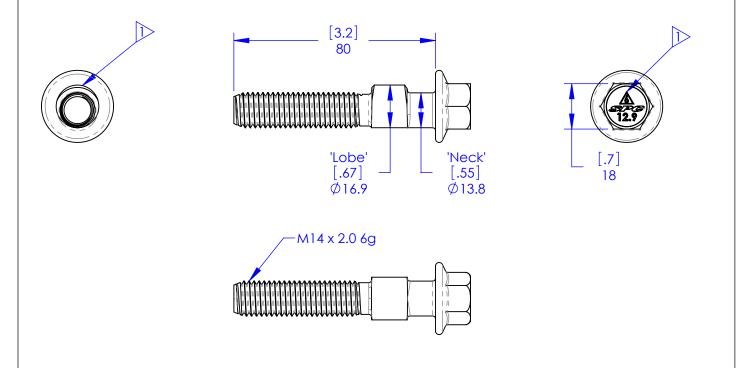
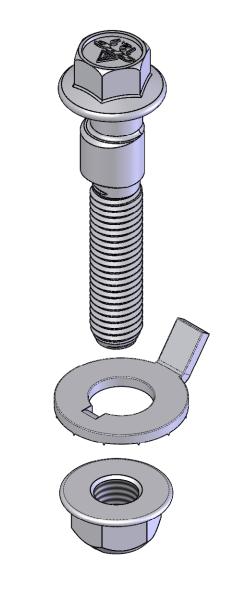
- Assure that 'point' at top of triangle around ID mark is aligned with direction of 'Lobe' offset from 'Neck' (both oriented at top in the end views shown)
 Finish: Geomet (Silver).
